DOT/FAA/RD-92/8

Performance of Insulated Pavements at Newton Field, Jackman, Maine

Maureen A. Kestler
Richard L. Berg

May 1992

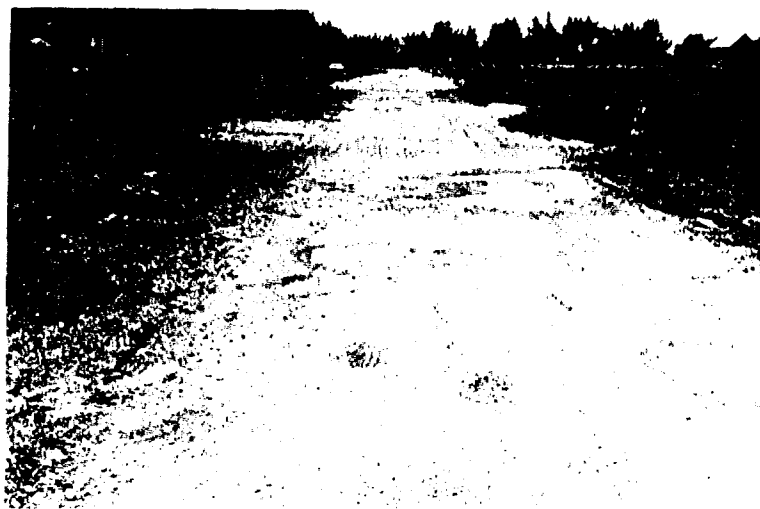
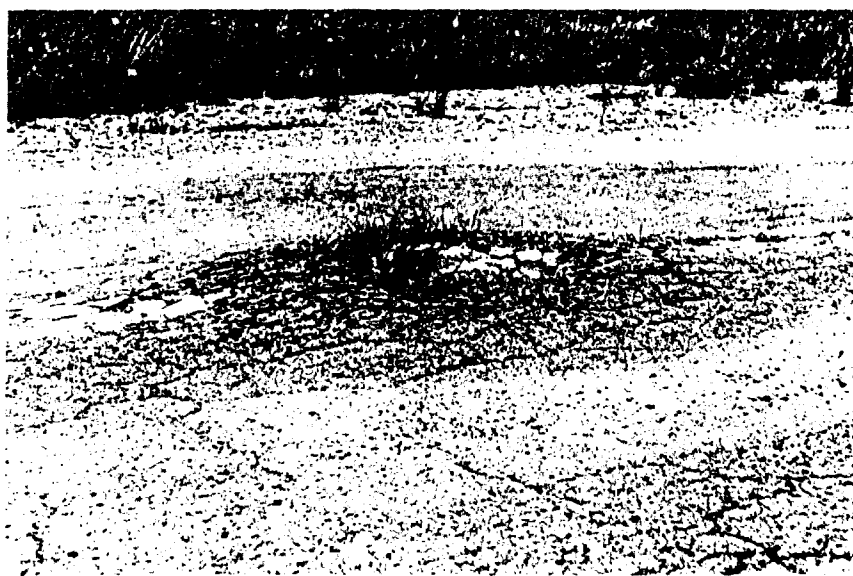
The runway at Newton Field was reconstructed in 1986. The old runway was in extremely poor condition, as is shown in Figure 2. The longitudinal and transverse pavement surface was highly irregular and was disintegrating as a result of moisture entering the large number of cracks. Although located in the same vicinity as the old runway, the new 2900- × 60-ft runway is longer, wider, and at a slightly different orientation than the old runway.

a. Looking northwest.

b. Boulder heave.

Figure 2. The Newton Field runway before 1986.

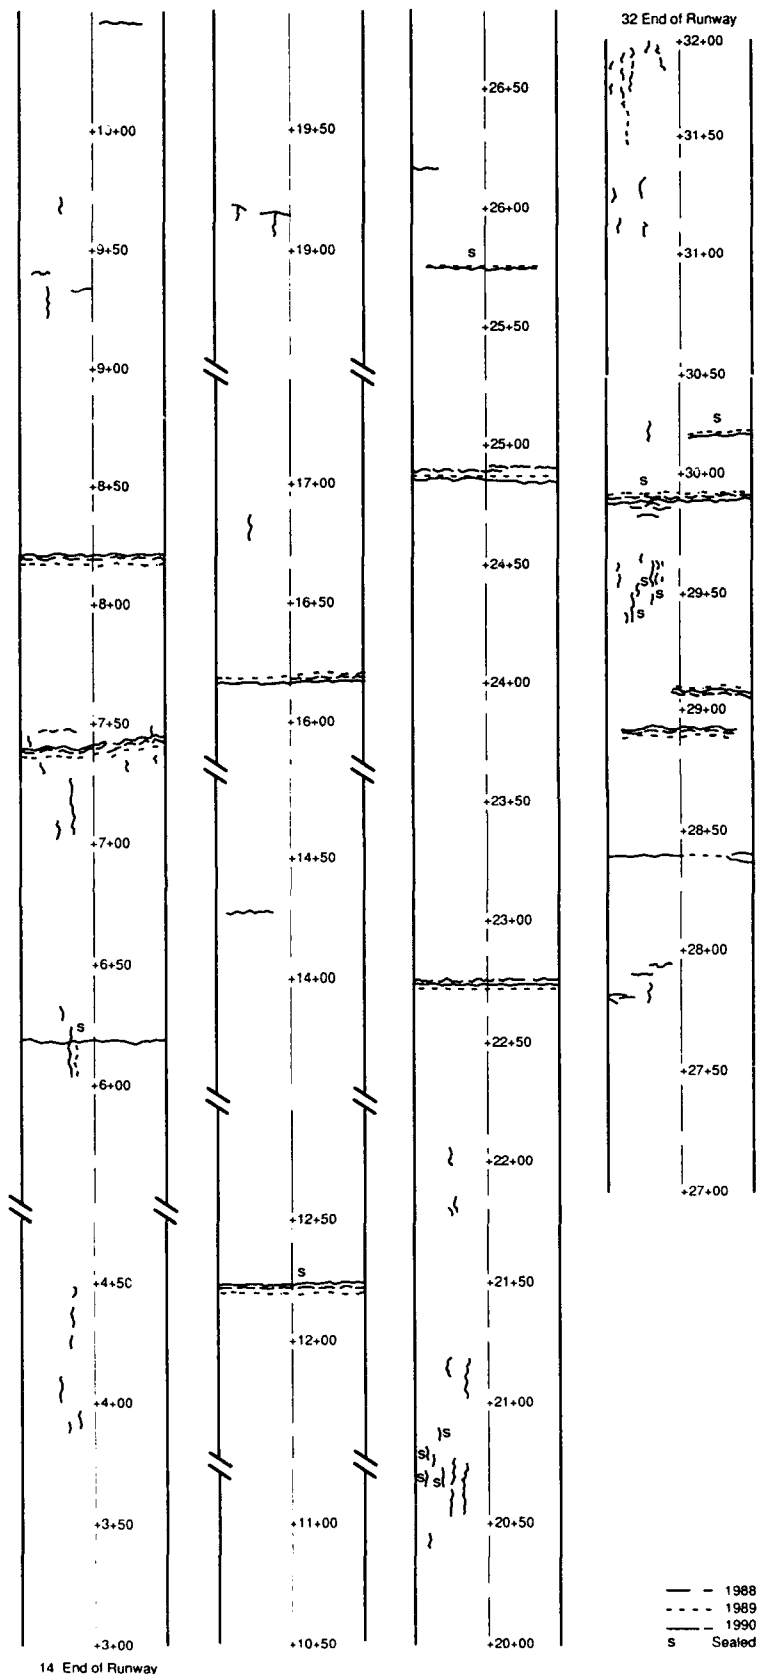
The progression of crack development following placement of the final 1 1/4-in. asphalt concrete lift in 1987 is shown in Figure 9. Although the cracks had been sealed in September 1989 with a rubberized crack sealer and polyfiber, nearly all cracks have since reopened. In all instances, the failure occurred due to a loss of adhesion between the asphalt pavement and the sealing agent. The crack shown in Figure 10a was unsuccessfully sealed with silicone shortly before being resealed with the rubberized crack sealer.

Figure 9. Newton Field pavement crack map.

en transverse cracks extend across, or nearly across, the entire runway, and two transverse cracks extend across the taxiway. Crack density is particularly high at the southeast (32) end of the runway; elsewhere, cracks are fairly evenly distributed.

2. Extreme pavement distress is exhibited by cracks up to 9 in. deep and by severe secondary cracking. It is recommended that both the pavement surface and the underlying insulation be monitored for horizontal displacement. From this it could be determined whether the extreme crack-related failures are due to differential movement caused by the extreme temperature fluctuations experienced by insulated pavements, movement of the asphalt concrete and frozen base, or shrinkage of the asphalt concrete due to accelerated aging.

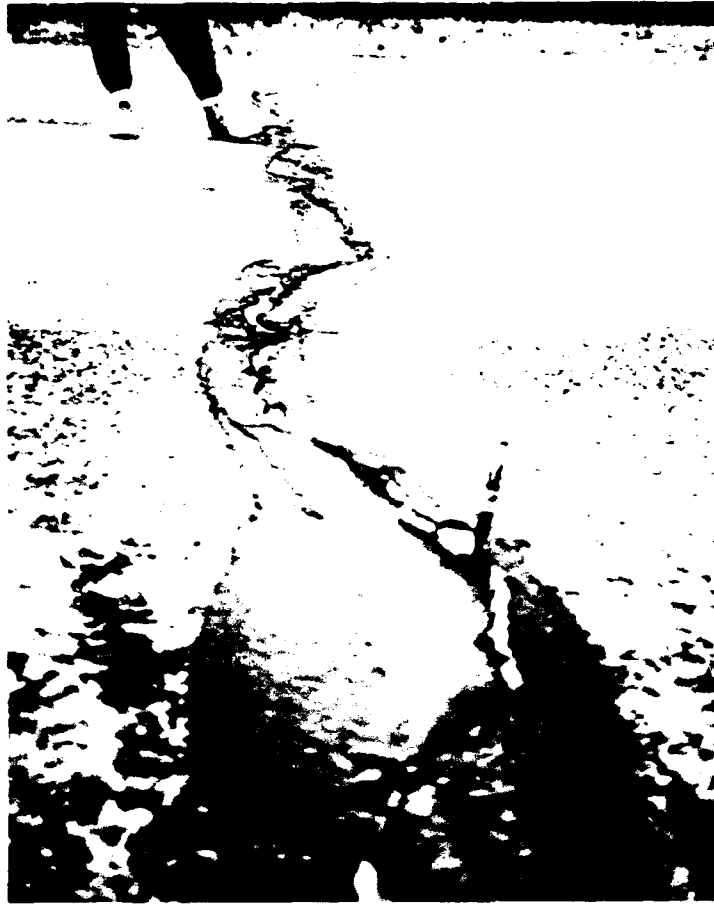
a. Crack at station 8+22 initially sealed with silicone, then with a rubberized crack sealer.

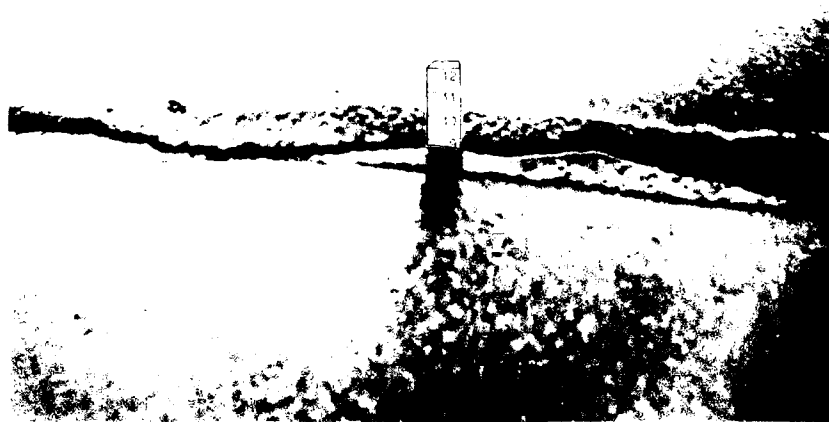
b. Crack at station 16+15.

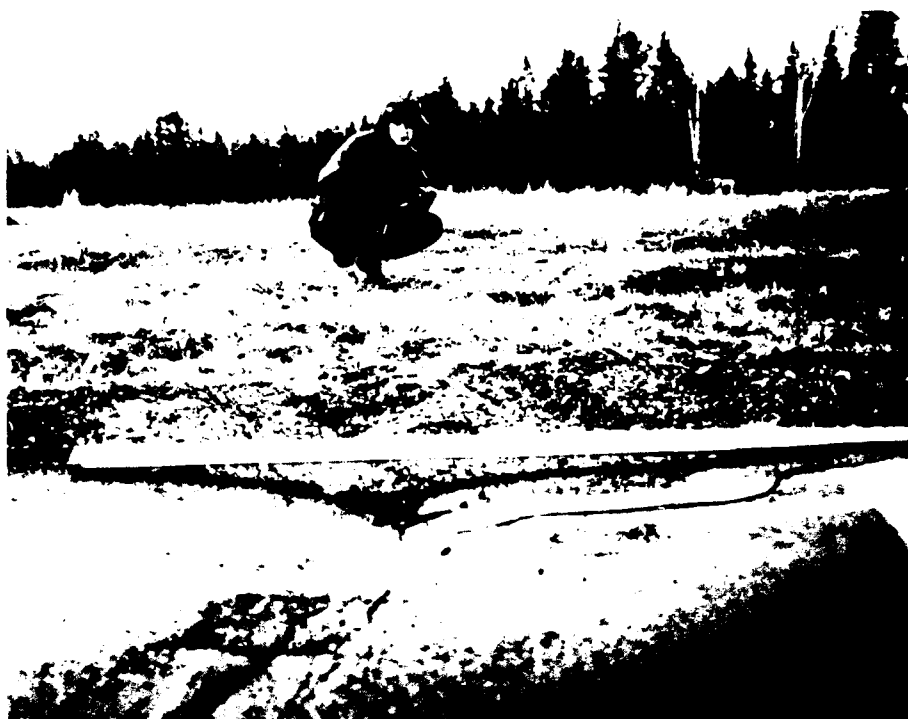
c. Settlement of pavement at station 29+95

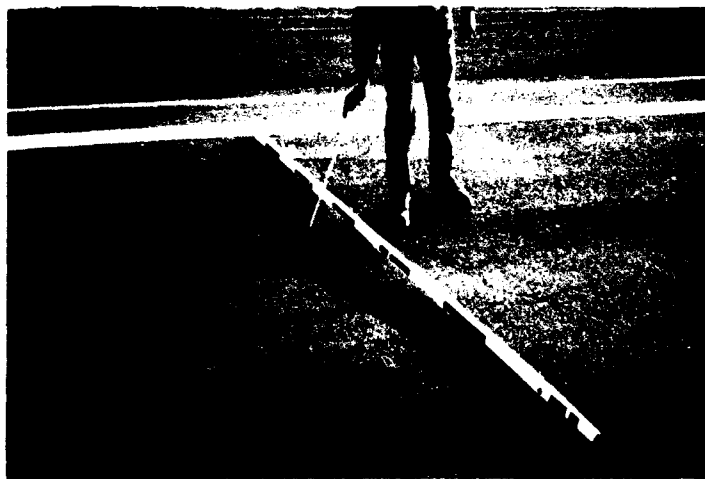
Figure 12. Differential frost heave near station 8+00. The "valley" is about 6 in. below the "ridges."

Localized differential heave was exhibited each spring in the vicinity of station 8+00 and between stations 29+00 and 32+00. Figure 12 depicts the irregular pavement surface near station 8+00 in early April 1988; in this area the differential movement was about 6 in. A variety of methods have been employed to investigate the causes of the localized differential frost heaving; the methods and observations are discussed later in this report.

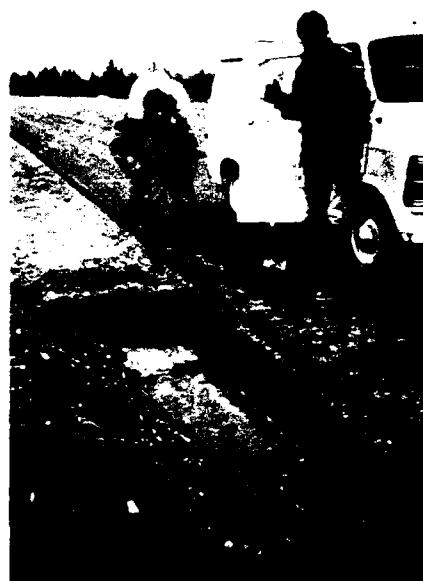
Figure 18. Station 7+75, south edge of Newton Field runway.

In April 1988, a 2- × 5-ft trench was hand-excavated immediately adjacent to the north edge of the runway at station 4+25. The insulation proved to be intact, with only a 1/4-in. gap between panels. A similar 2- × 8-ft trench at station 7+75 on the south edge of the runway again yielded intact insulation; however, a 2 1/2-in. gap was observed between insulation panels (Fig. 18). A third trench was started at station 4+75 on the south edge of the runway, but was abandoned when insulation was not encountered at the excavated depth of 18 in.

a. Trench excavation

b. Gap between insulation panels

1. Field investigations confirm that gaps in excess of 2 in. have developed between the buried insulation panels in the shoulder area immediately adjacent to the asphalt pavement, indicating that similar discontinuities have probably developed beneath the asphalt pavement itself. Further studies are recommended to assess the thermal effects of panel spacing on both the thermal regime and frost heaving of insulated pavements.
